**Determination of Scuffing Resistance**

Report Number: **T15/129-3**  
 Page 1 of 2

**Client:** Thermagrip Ltd  
**Installer:** Thermagrip Ltd  
**Product for test:** Thermagrip  
**Description of specimen:** (300 x 300 x 3)mm checker plate coated with preform thermoplastic dressed with a mixture of glass grains and fused alumina.  
**Binder type:** Thermoplastic **Aggregate type:** Glass and fused alumina  
**Date of application:** n/a **Date received:** 08-May-15

<b>Test Method: Determination of scuffing resistance, TRL 176 Appendix G</b>			
Tested in accordance with TRL 176, as amended by BBA " Guidelines Document for the Assessment and Certification of High Friction Surfaces for Highways" March 2008. The material was scuffed at 35°C as specified for a TYPE 3 high friction surfacing . Skid resistance value was determined using slider 96 (96 IRHD) since this is more simulative of hard solid tyres as found on fork lift trucks Test results are compared to an untreated specimen of steel checker plate			
<b>Laboratory tests</b>	<b>Thermagrip</b>	<b>Untreated plate</b>	<b>BBA HAPAS requirement for TYPE 3 HFS</b>
<b>Initial Properties</b>			
Texture depth (mm)	<b>0.9</b>	1.2	1.0 mi

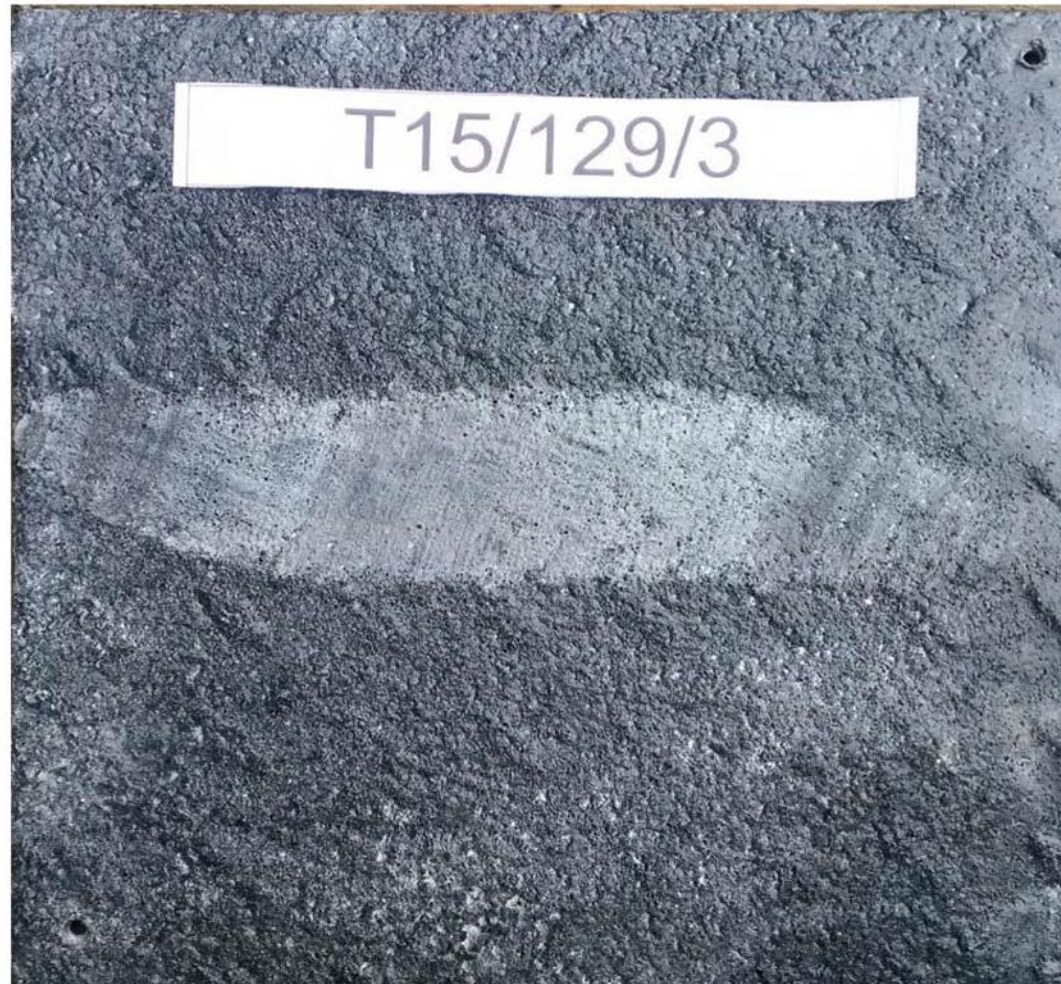
Specimen Number	<b>129-3</b>	
Identification of slab	<b>129-3</b>	
Texture depth of substrate (mm)	1.2	
Thickness of coating (mm)	3.0	
SRV before Scuffing	64.0	
Date of test	<b>20/05/2015</b>	
Time of test	<b>10:15</b>	
Test Temperature (°C)	<b>35.3</b>	
Tyre Pressure (Bar)	Initial	<b>3.1</b>
	Final	<b>3.1</b>
Tyre tread depth (mm)	Initial	<b>1.5</b>
	Final	<b>1.5</b>
Angle of Tyre to direction of travel	<b>20°00'</b>	
Surface texture depth (mm)	Initial	<b>0.9</b>
	Final	<b>0.6</b>
Loss of texture depth (%)	<b>30.2</b>	
SRV after Scuffing	50.0	
Erosion Index	<b>0.0</b>	
Description of visual condition	<b>No faults or anomalies were observed</b>

After 500 wheel passes at 35°C
